Manhole Inspection Summary

Manhole # S41KK_029MH

Insp Date: **12/19/07 9:41 AM**

Location Address: **1302 LAFAYETTE AVE**

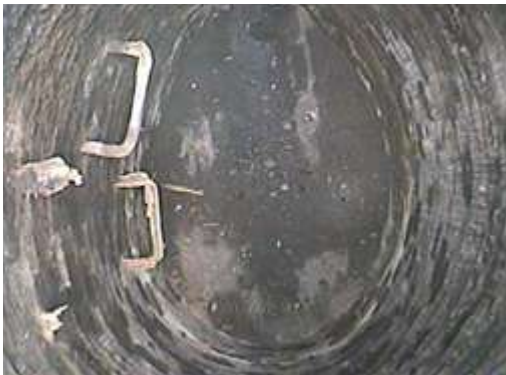
Defect 2

Count: **5** Missing: **2** ☒ **Corroded**

MISSING AND CORRODED STEPS

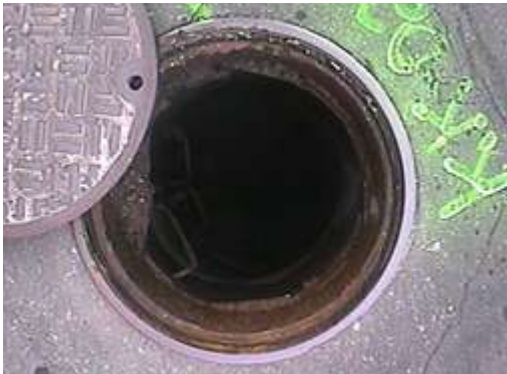
Defect 1

Offset: **3** (in.)

FRAME OFFSET

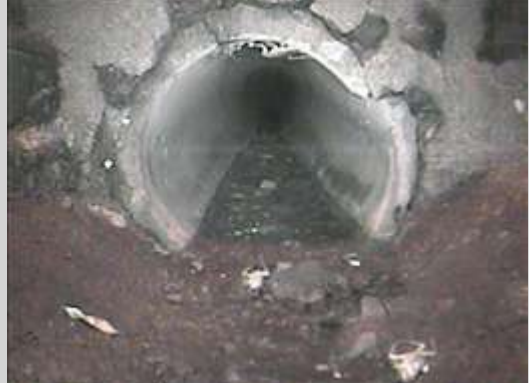
12 O'Clock Outflow

8 in. Circular Gravity Sewer
Pipe Out @ 12 O'Clock

Infiltration: **None** Pipe Seal Cond: **Cracked**
